1. Report No. NTSB-AAR-75-16	2. Government Accession No.	3. Recipient's Catalog No.	
4. Title and Subtitle Aircraft Accident Report - Trans World Airlines, Inc., Boeing 727-231, N54328, Berryville, Virginia December 1, 1974		5. Report Date November 26, 1975	6. Performing Organization Code

At 1110 e. s. t., December 1, 1974, Trans World Airlines, Inc., Flight 514, a Boeing 727-231, N54328, crashed 25 nautical miles northwest of Dulles International Airport, Washington, D. C. The accident occurred while the flight was descending for a VOR/DME approach to runway 12 at Dulles during instrument meteorological conditions. The 92 occupants -- 85 passengers and 7 crewmembers -- were killed and the aircraft was destroyed. *1110*

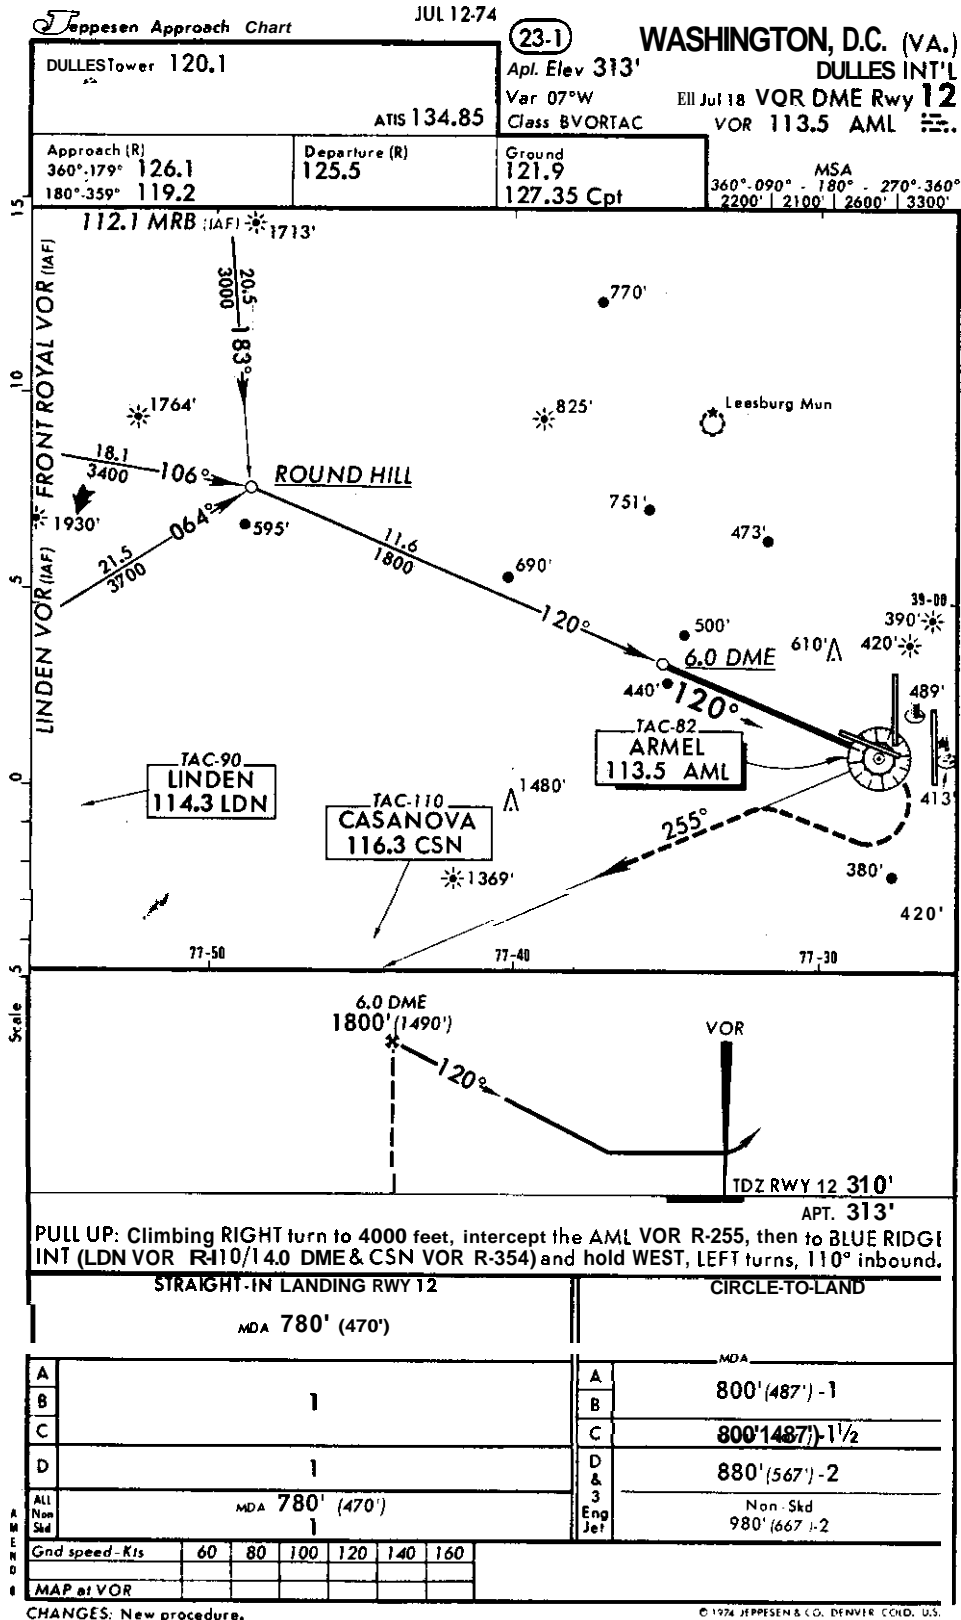
APPENDIX D

The information available to the pilot, including the approach chart, should have alerted the crew that an unrestricted descent would be unsafe. It does appear to the Board that there was a deficiency in the chart. This particular approach chart depicted the profile view from the final approach fix to the airport. It did not depict the intermediate fix, Round Hill, with its associated minimum altitudes. This information was available from the plan view of the chart, but it appears that the crew gave their primary attention to the profile. If this was the

(3) Inadequate depiction of altitude restrictions on the profile view of the approach chart for the VOR/DME approach to runway 12 at Dulles International Airport.

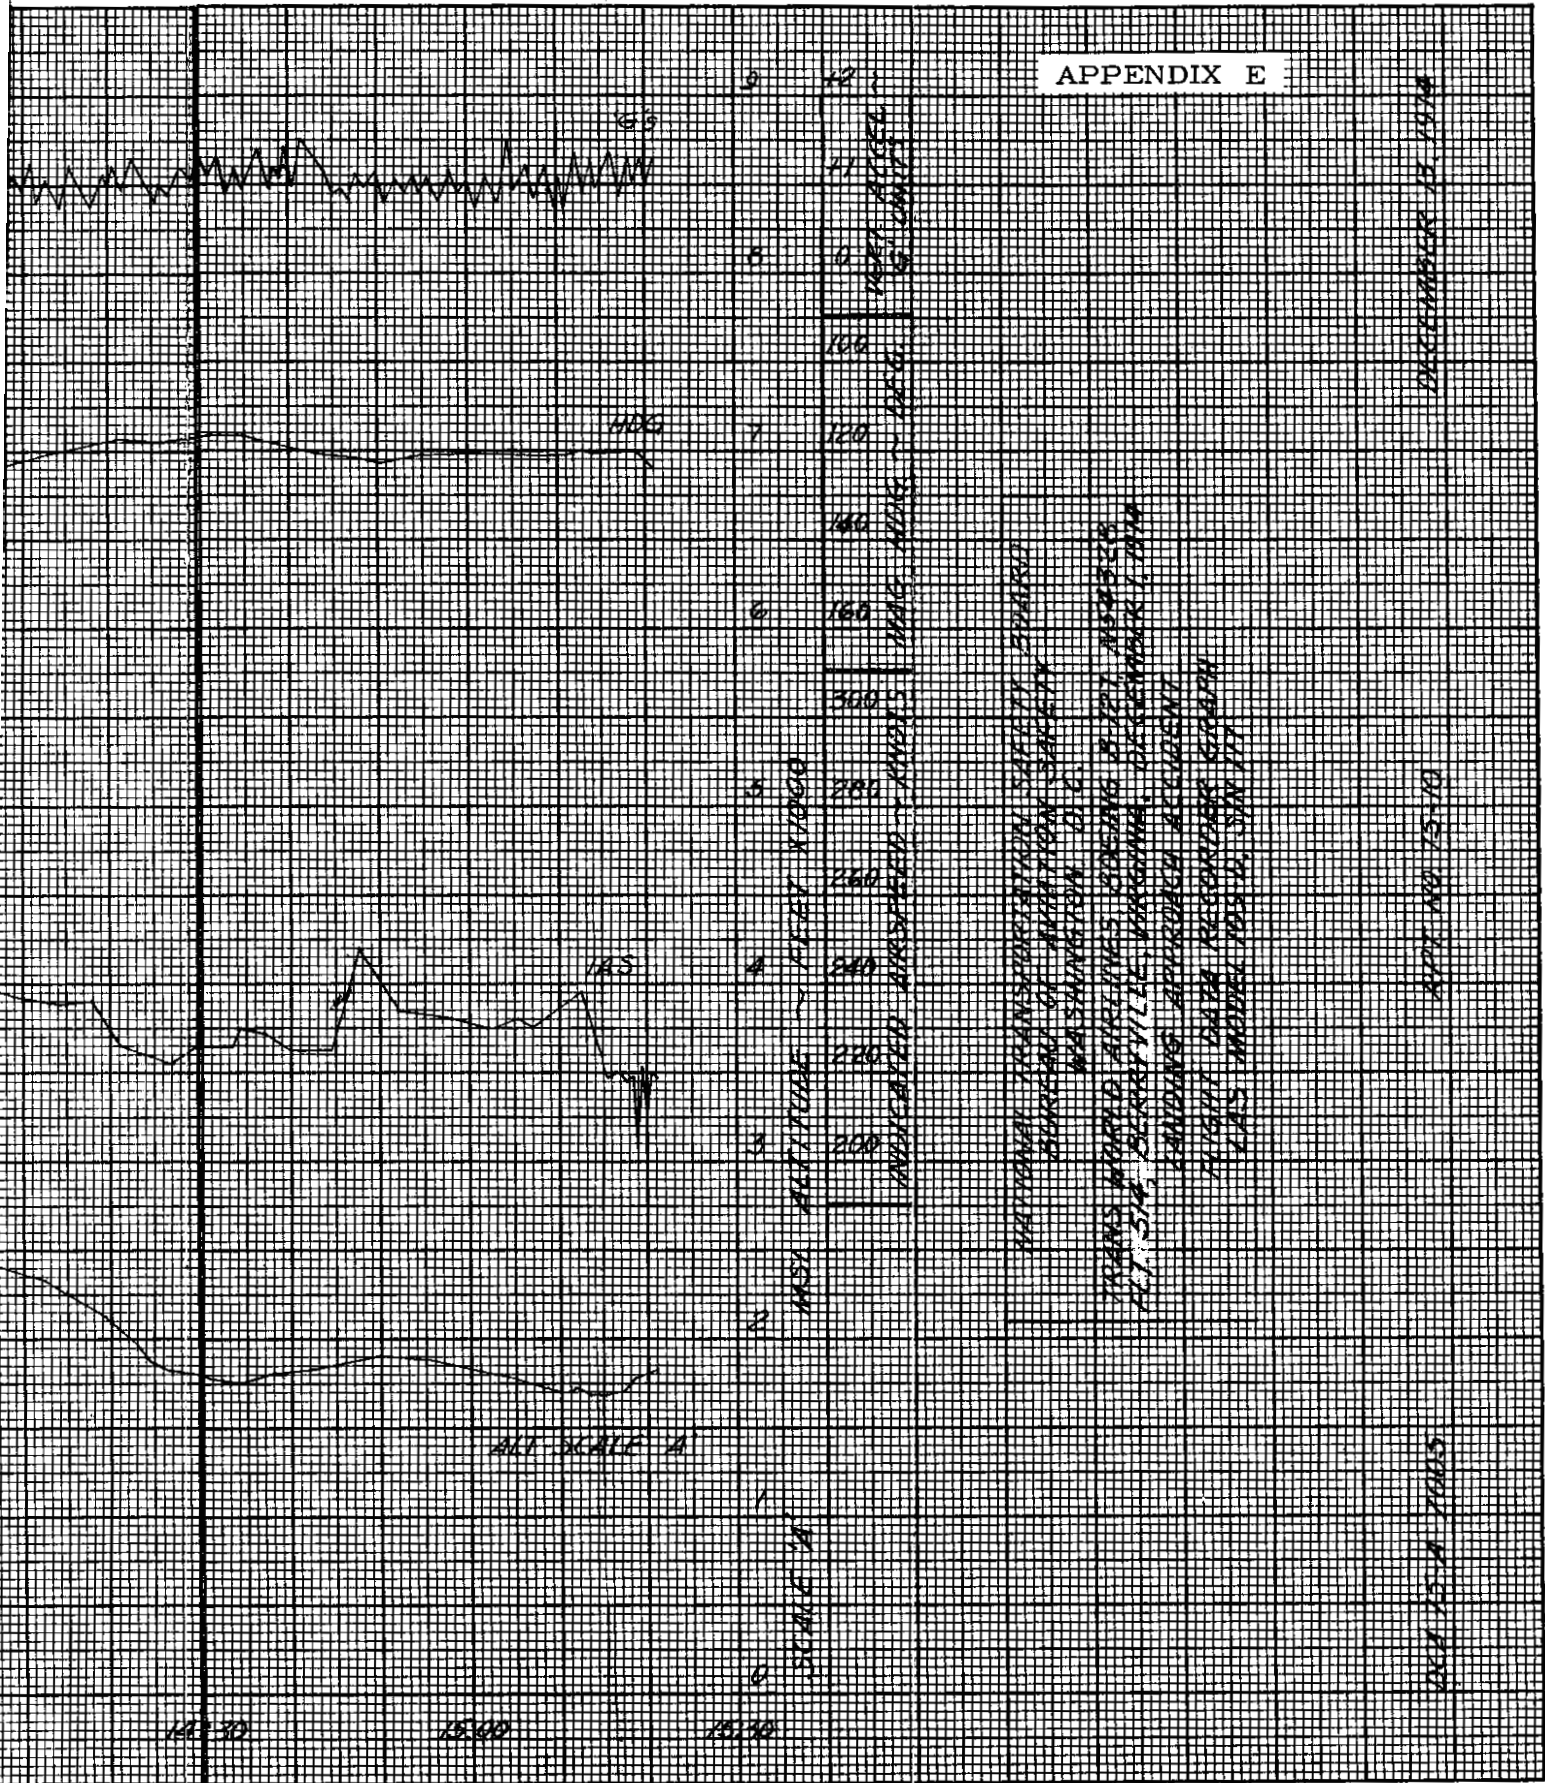
APPENDIX E

The flight data recorder parameter traces were clearly recorded. There were no recorder malfunctions. A readout was made of the last 15 minutes 25 seconds of the flight. There was a small gap in the vertical acceleration trace shown on the data graph at time 13 minutes 30 seconds because of foil damage which obliterated the trace. (See Appendix E.)

The crew's comments regarding the altitude and the power indicate that the first officer was not flying the aircraft at the target altitude of 1,800 feet. The Board examined the flight data recorder trace and found that while there was evidence of moderate turbulence, it was probably not of sufficient magnitude to prevent the first officer from maintaining the desired altitude. There was also no evidence that there was any problem within the aircraft that would have prevented the pilot from staying at 1,800 feet. Therefore, the Board concludes that the deviation below the target altitude was probably a result of the combination of the first officer's flying technique and the turbulence.

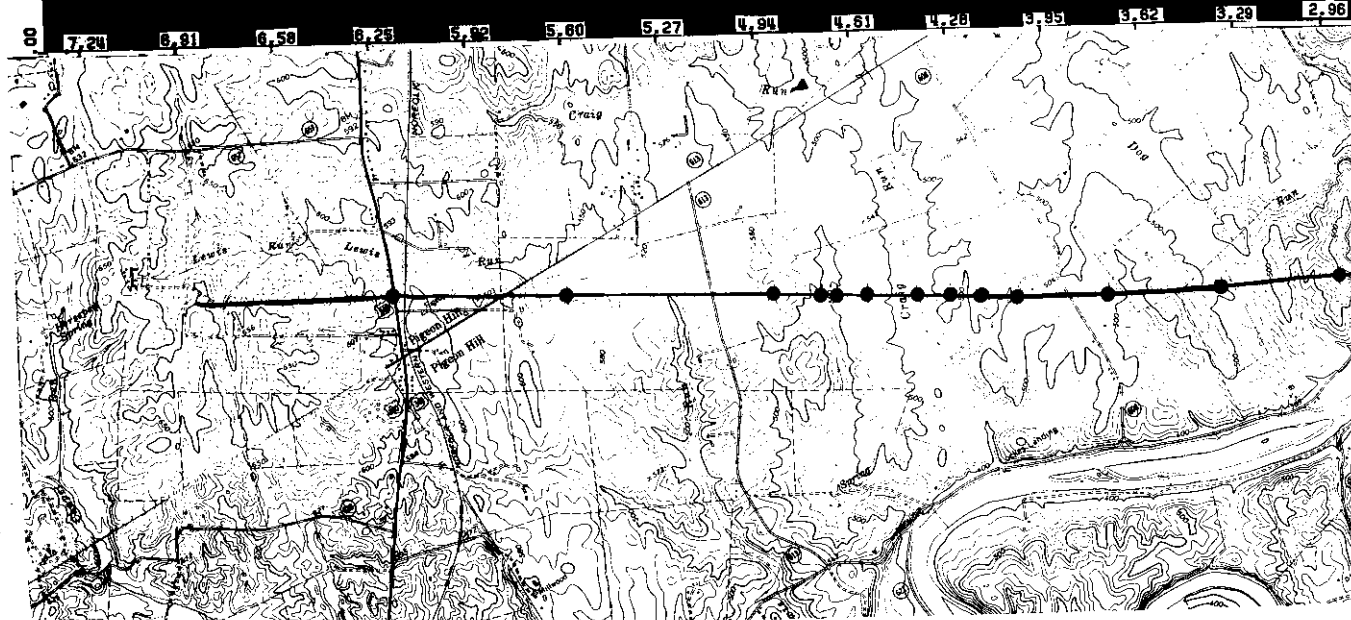
DESCENT PROFILE

Shortly after 1107, the captain first expressed doubt concerning the action he should be taking and the minimum altitude to which he was descending. He noted that the minimum altitude to Round Hill (from Front Royal) was **3,400** feet. He discussed the chart with the crew and again decided that the flight was authorized to descend to 1,800 feet, the intermediate approach segment altitude. Seconds later the altitude alert system warning sounded indicating that the flight was approaching 1,800 feet and the captain stated that he had seen the ground "a minute ago." The first officer indicated that he had seen the ground also. Apparently they had only fleeting glimpses of the ground and did not derive any relative altitude information from what they saw. The first officer mentioned the power and the captain noted that they had a high sink rate. Then the captain said that the ground should be visible in just a minute. At 1108:57, the altitude alert sounded again. This sound may have been caused by a pilot positioning the altitude alert control to cancel further warnings. This is a normal TWA procedure once cleared to descend below the initial approach altitude. In this particular case the aircraft had arrived at the altitude the captain had determined to be the initial approach altitude, and clearance for the approach had been received. Subsequent altitude information was provided by the barometric altimeter and height-above-the-ground information was provided by the radio altimeter. There was some conversation regarding a **downdraft** and the radio altimeter warning horn sounded then stopped. The captain said at 1109:20, "Get some power on." The radio altimeter warning horn sounded again and at 1109:22, the sound of impact was recorded.

Two reasons why the aircraft might have been below its target altitude of 1,800 feet are evident. First, the aircraft was entering ground effect as it got closer to the ground and this may have caused an error in the pitot static system which caused the altimeter to indicate an altitude higher than the actual aircraft altitude. Second, it is possible that the high winds blowing over the rough terrain in the accident area may have caused a pressure change which affected the altimeter indication. However, the crew's evident concern about the altitude was indicated by the captain's order regarding the power and the first officer's comments about the downdraft when the aircraft went below the target altitude. Based on the evidence available, the Safety Board concludes that there was no significant error in the altitude information presented to the pilots by their instruments.
