1. Report No. NTSB-AAR-75-16	2. Government Accession No.	3. Recipient's Catalog No.	
4. Title and Subtitle Aircraft Accident Report - Trans World Airlines, Inc., Boeing 727-231, N54328, Berryville, Virginia December 1, 1974		5. Report Date November 26, 1975	6. Performing Organization Code

At 1110 e. s. t., December 1, 1974, Trans World Airlines, Inc., Flight 514, a Boeing 727-231, N54328, crashed 25 nautical miles northwest of Dulles International Airport, Washington, D. C. The accident occurred while the flight was descending for a VOR/DME approach to runway 12 at Dulles during instrument meteorological conditions. The 92 occupants -- 85 passengers and 7 crewmembers -- were killed and the aircraft was destroyed. *1110*

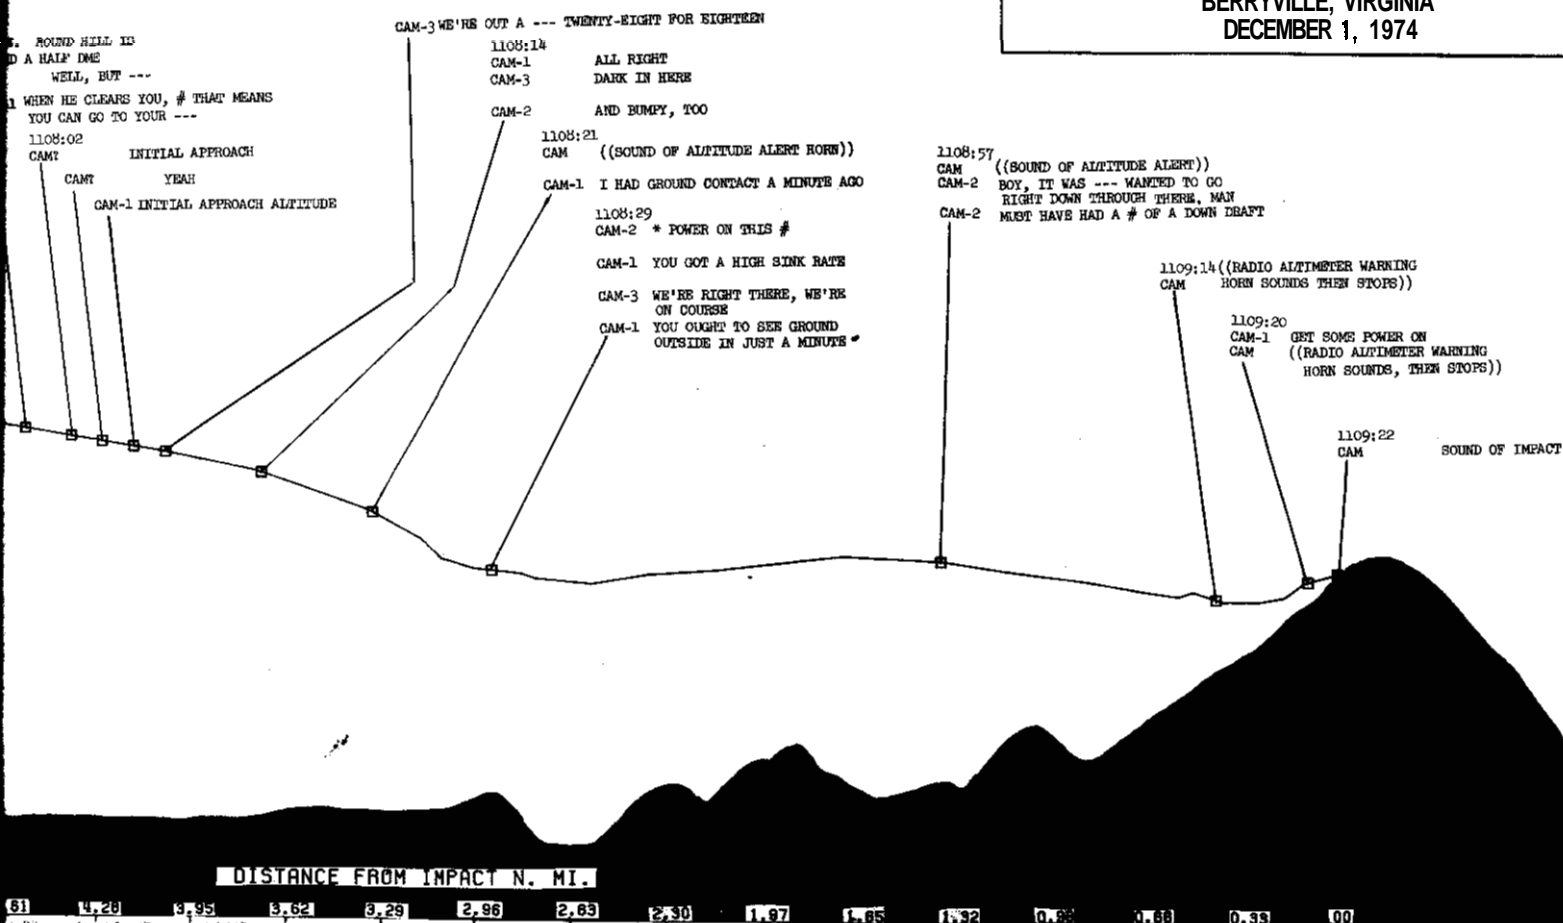
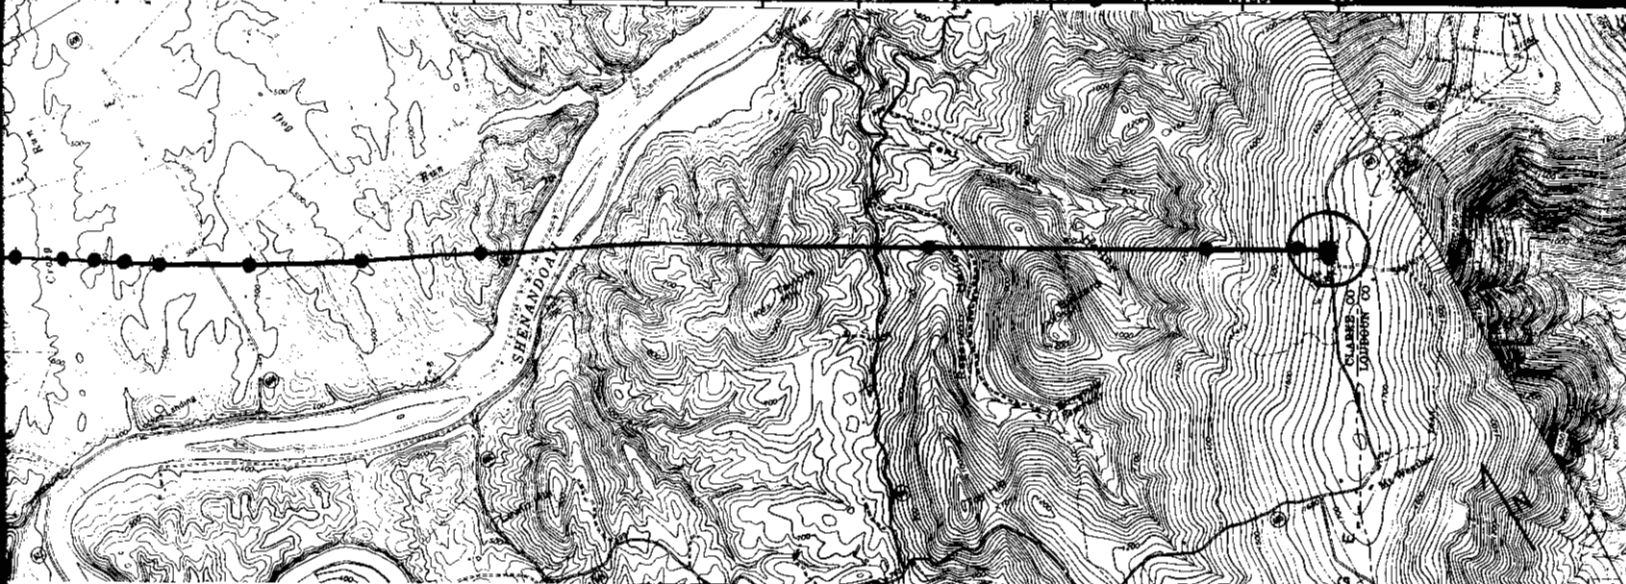
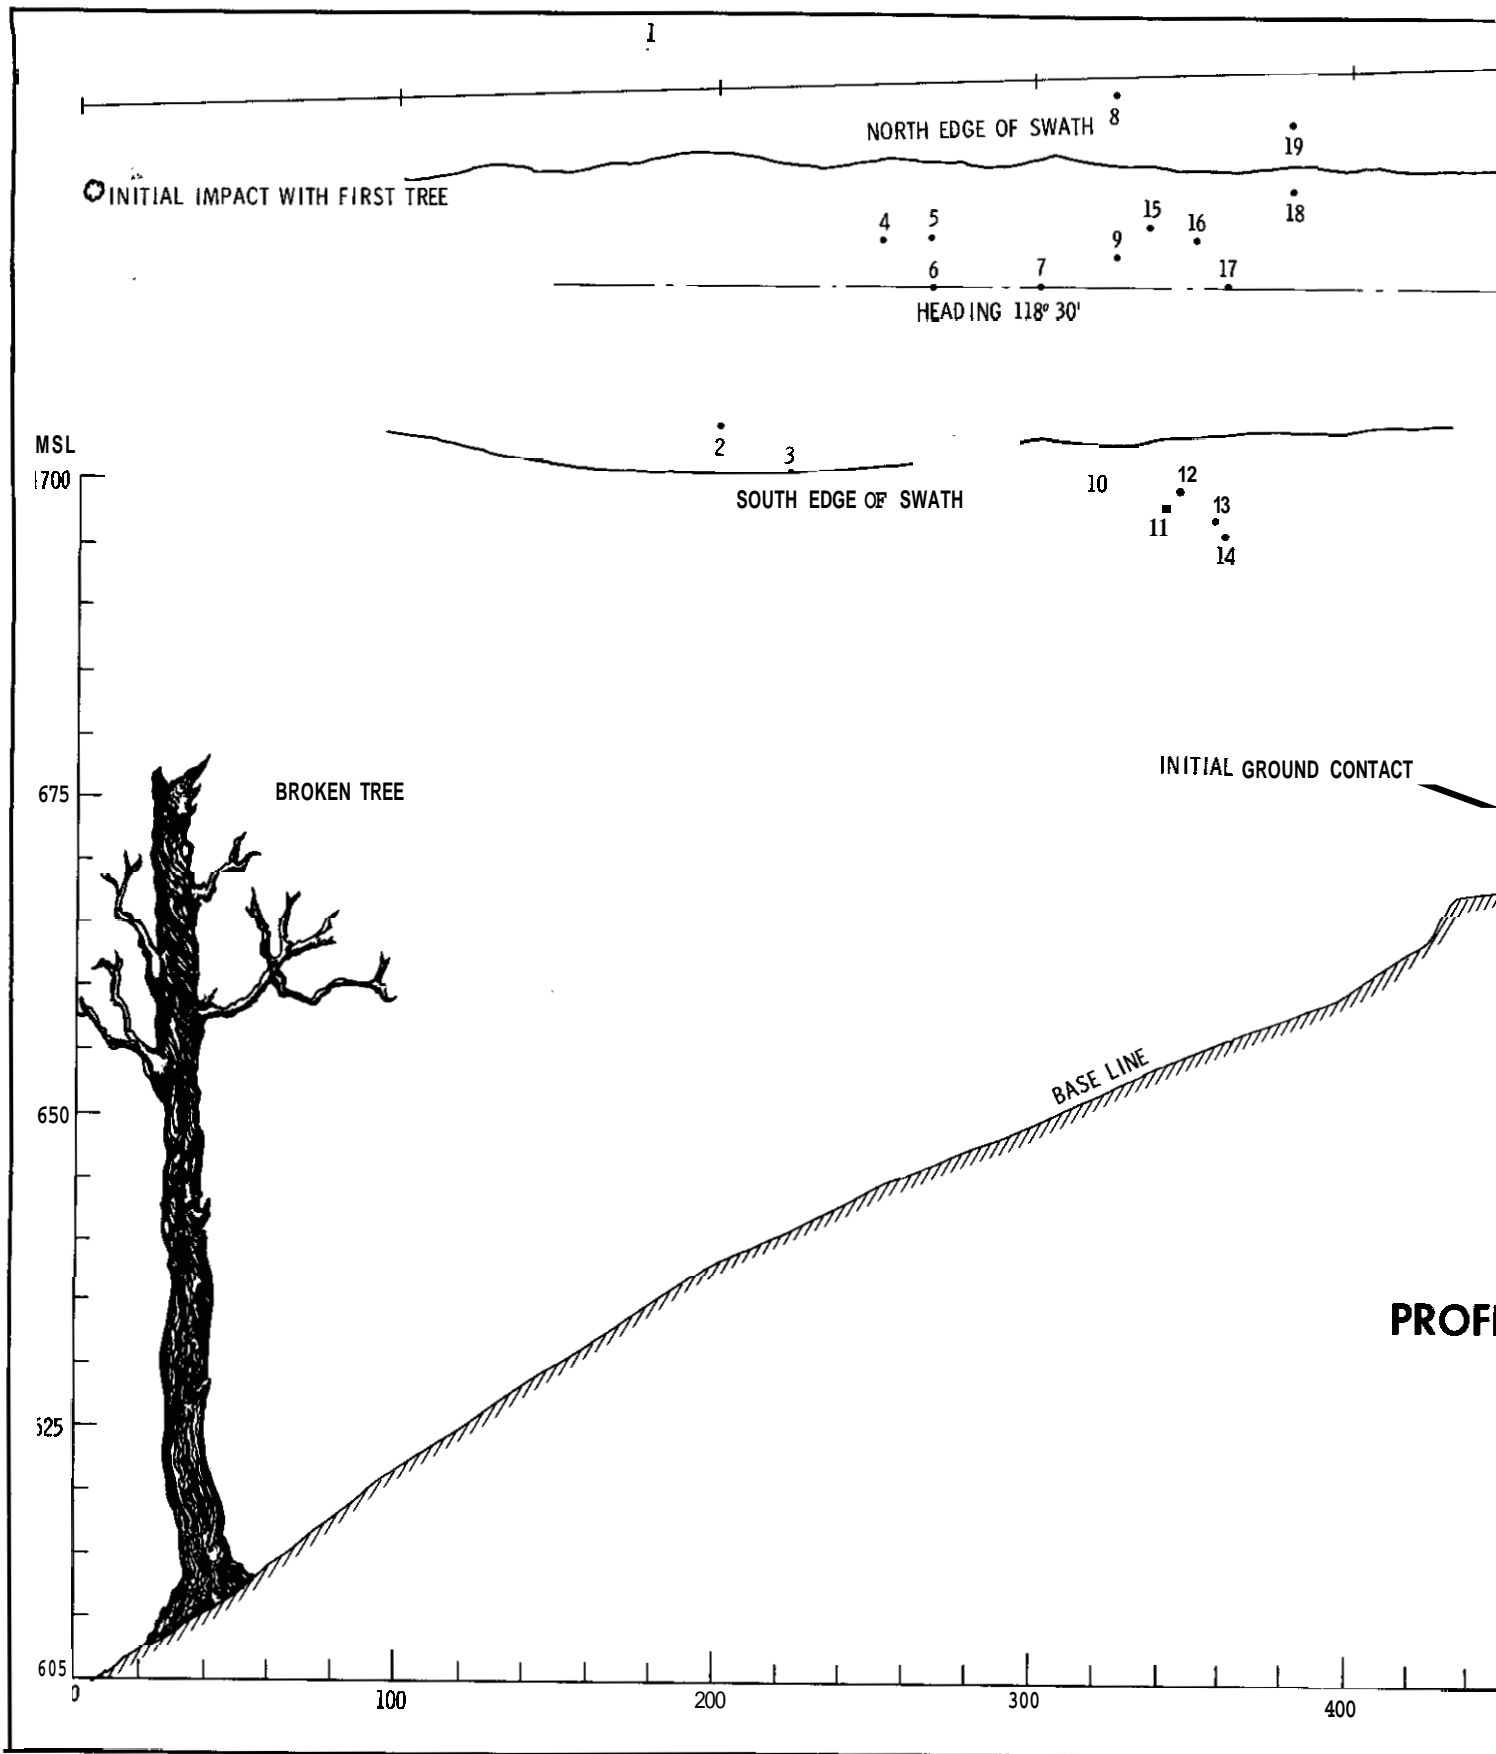
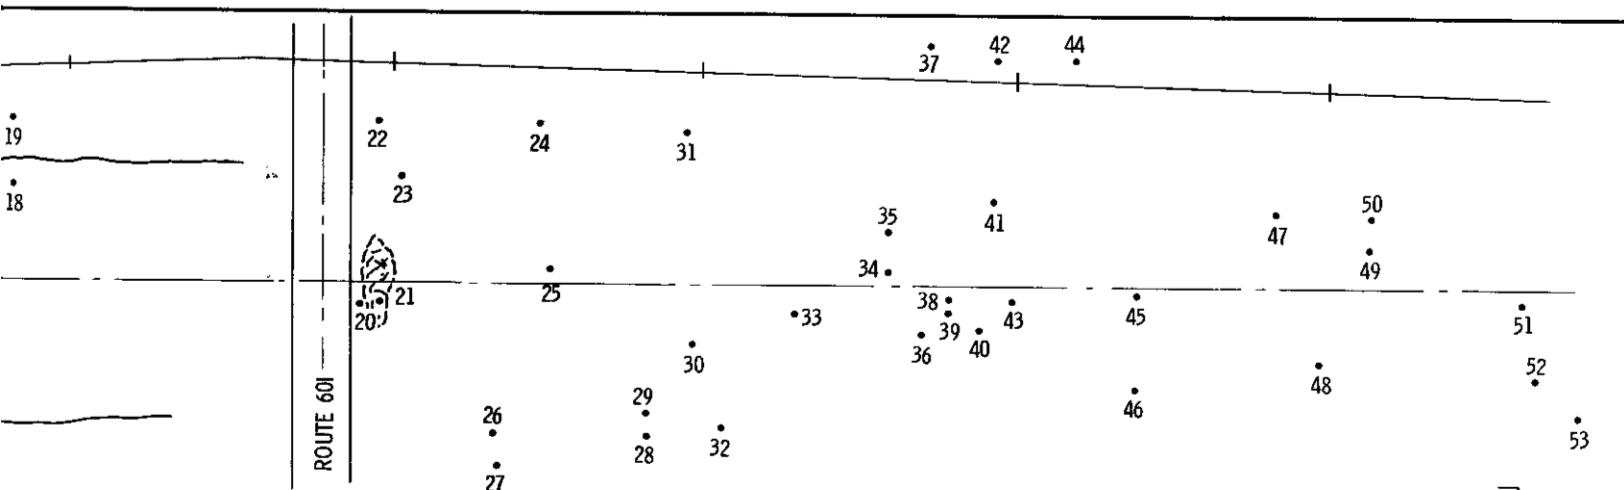
DESCENT PROFILE

TRAMS WORLD AIRLINES
B727-231, N54328, FLIGHT 514
BERRYVILLE, VIRGINIA
DECEMBER 1, 1974

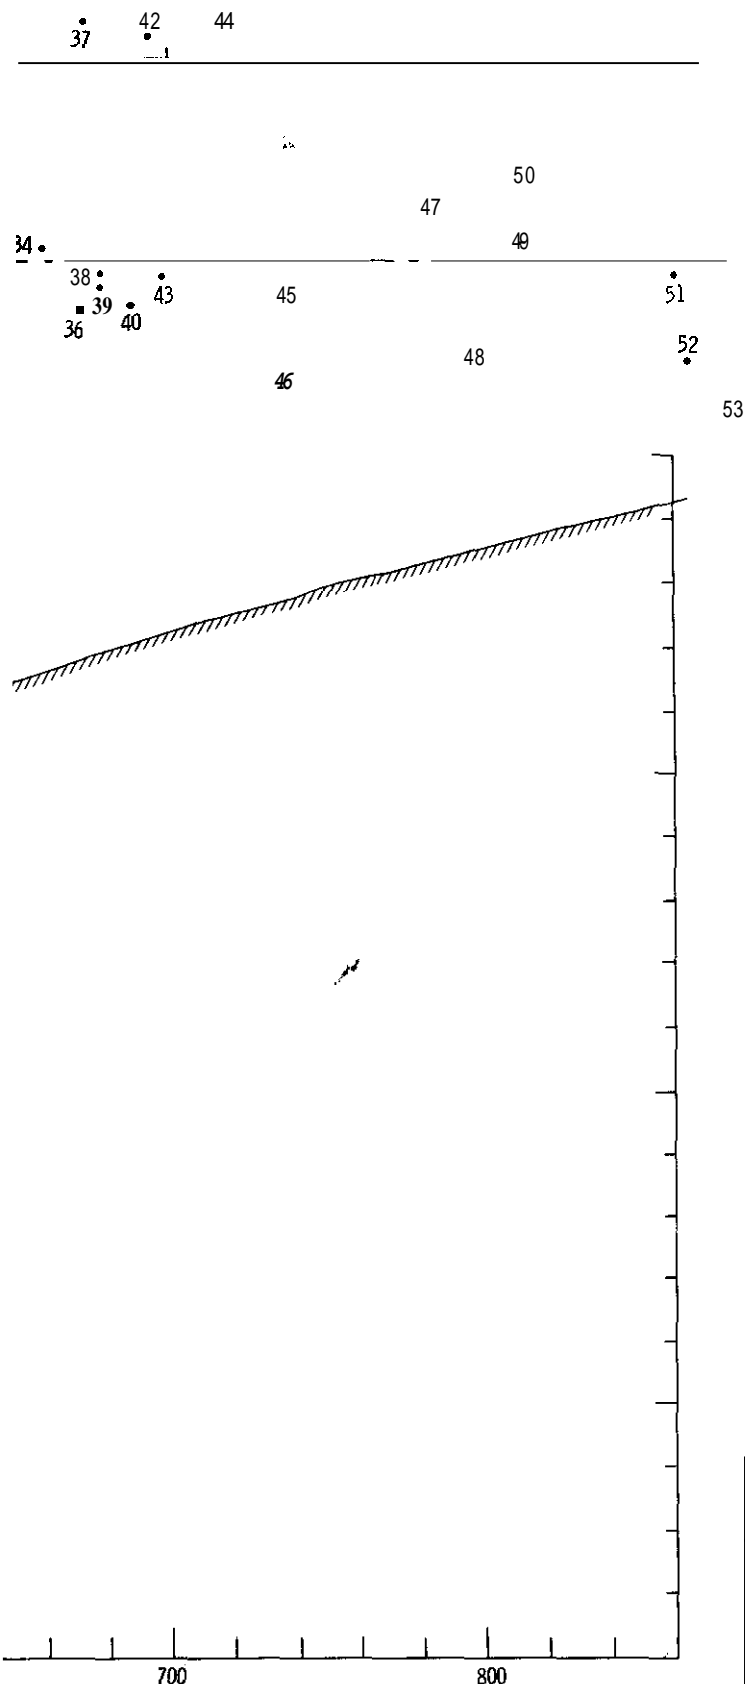
1. FIRST AIRCRAFT STRUCTURE (UNIDENTIFIED)
2. OUTBOARD AILERON SECTION LEFT SIDE
3. AILERON SECTION RIGHT SIDE
4. SLAT SECTION LEFT SIDE
5. REAR SPAR SECTION LEFT SIDE
